## GETTY COPPER INC.

Getty Copper Extends Mineralization Below Getty North Deposit and Identifies Potential New Mineralized Zone.

# GETTY NORTH SECTION - LOOKING NW

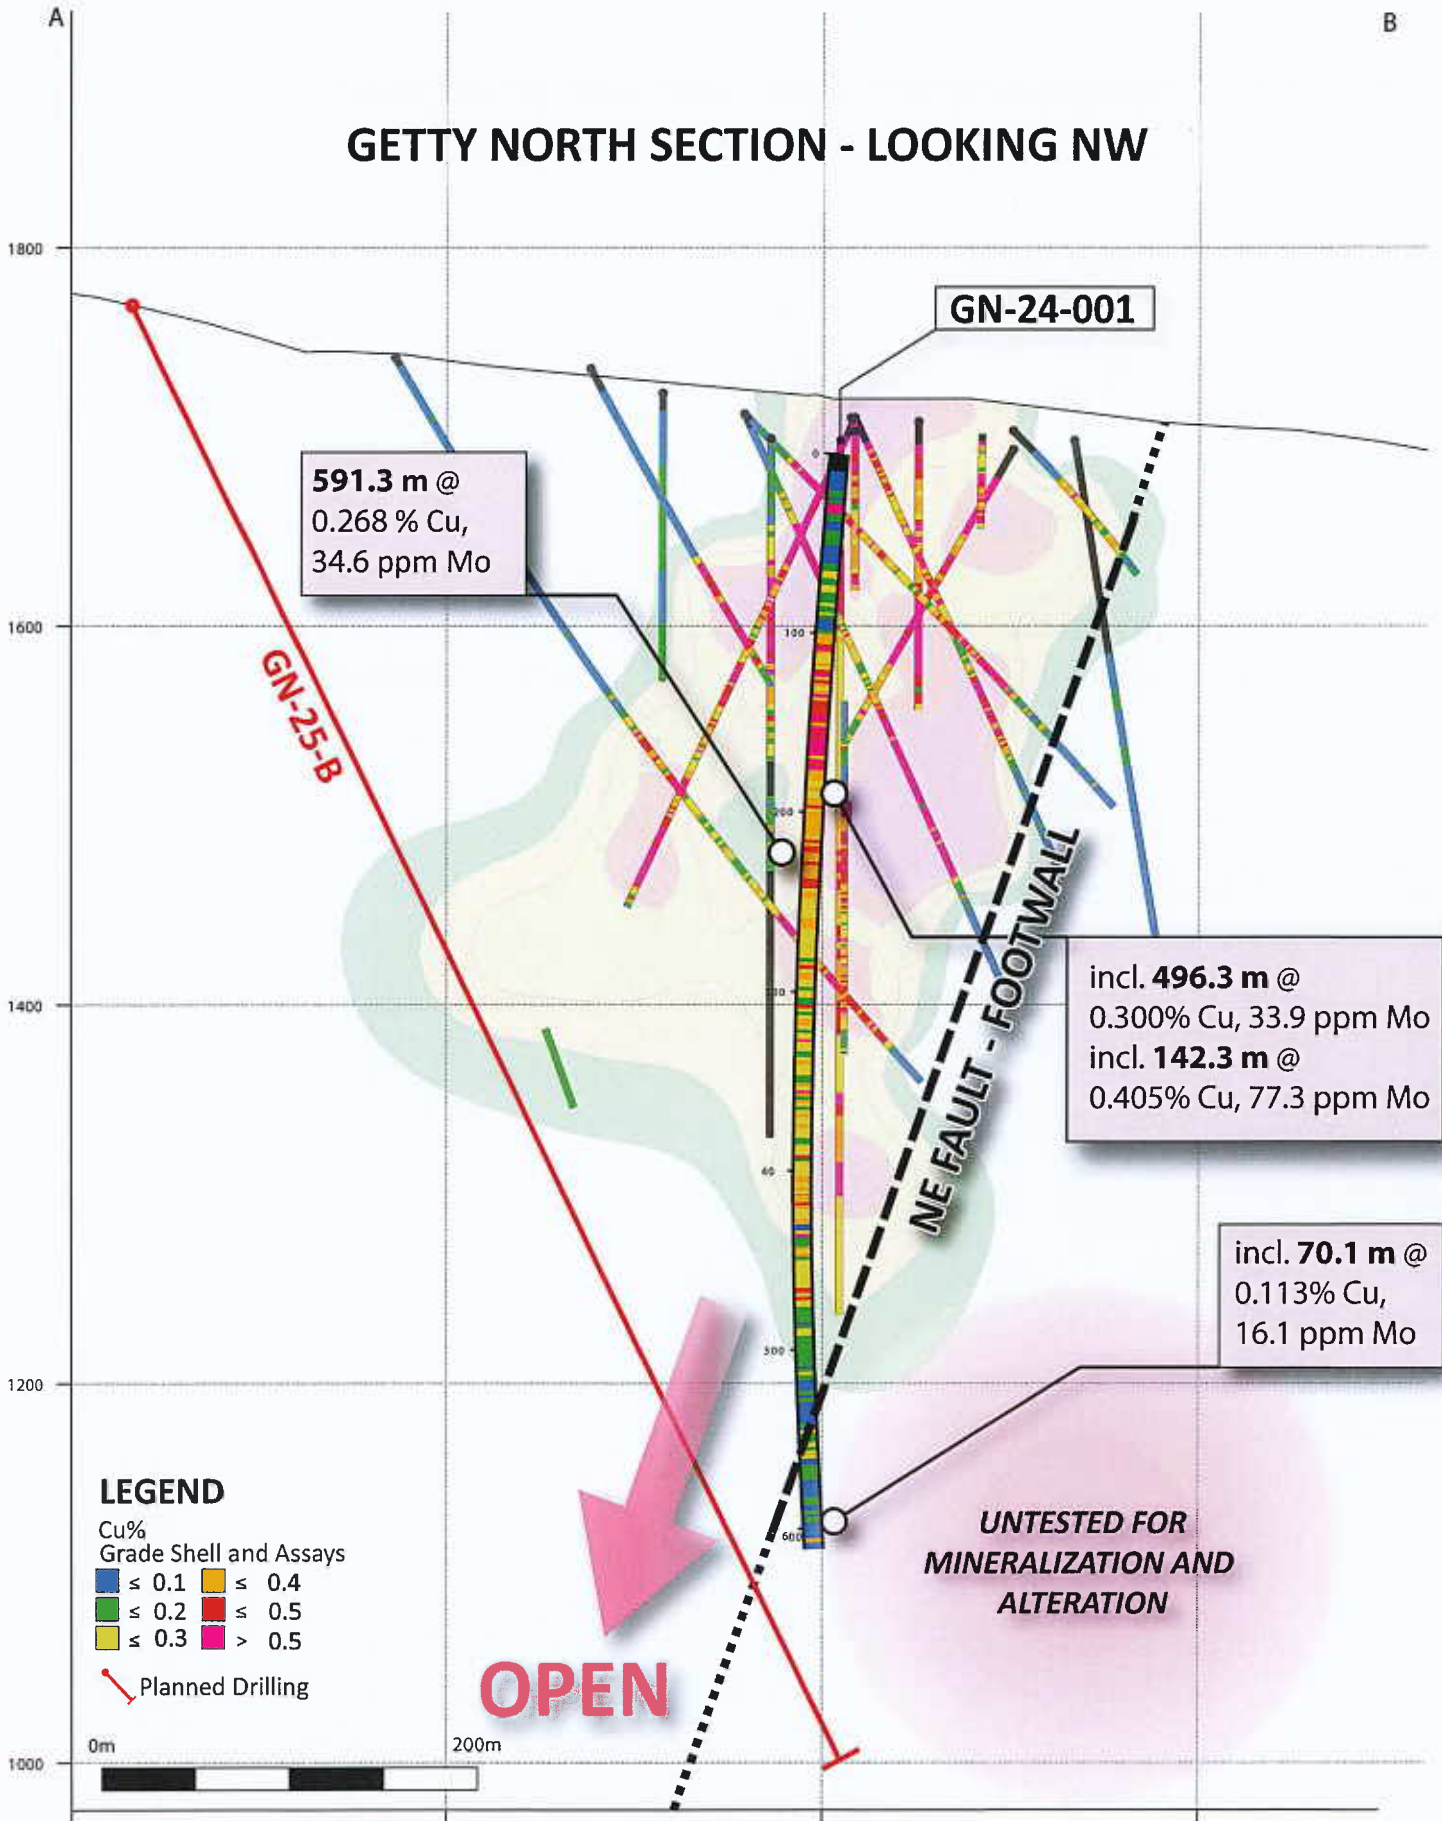
591.3 m @  
0.268 % Cu,  
34.6 ppm Mo

incl. 496.3 m @  
0.300% Cu, 33.9 ppm Mo  
incl. 142.3 m @  
0.405% Cu, 77.3 ppm Mo

incl. 70.1 m @  
0.113% Cu,  
16.1 ppm Mo

Drillhole GN-24-001 was successful in extending Cu and Mo mineralization 125 m below known mineralization and may represent a new zone. Drilling was planned to provide valuable multi-element data for the deposit, and to test the deposit at depth. The hole intersected 496.3 m of 0.300% Cu and 33.9 ppm Mo prior to intersecting the Northeast Bounding fault at a depth of 523 m.

A new mineralized zone was intersected in the footwall of the Northeast Bounding fault, which had previously been believed to limit the Getty North deposit to the east and northeast. Mineralization and porphyry alteration were observed in the footwall of the fault indicating the potential that the faulted off portion of the Getty North Deposit or another Cu mineralized porphyry could exist in the footwall of the Northeast Bounding fault. The grades below the fault are reduced by related low angle faulting in the interval, and Getty Copper is planning a follow-up drill program to test potential down plunge extensions and footwall mineralization below the Getty North Deposit.
